Re: Faust v. Autoliv

## SUBJECT COLLISION

## VEHICLE INSPECTIONS AND PHYSICAL EVIDENCE

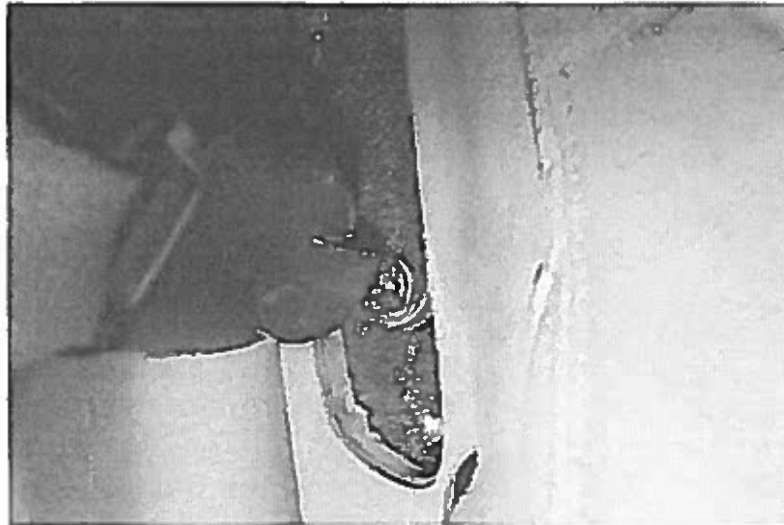
*Figure 1: Right-front deployed (retracted) OBA pretensioner*

For the right-front passenger position, the webbing has been cut in two locations. The cut ends match up indicating that all of the webbing is present and accounted for. The seat-mounted outboard anchor (OBA) has a pretensioner which appears deployed (it appears retracted) (Figure 1). The latch plate was found latched in the buckle; the latch plate was removed, inspected and then latched in the buckle for safe-keeping. The cover on the latch plate is missing (Figure 2a). The latch plate is a locking latch plate design. There are load marks on the plastic clamping surface of the latch plate where it interacted with the webbing (Figures 2b-d).

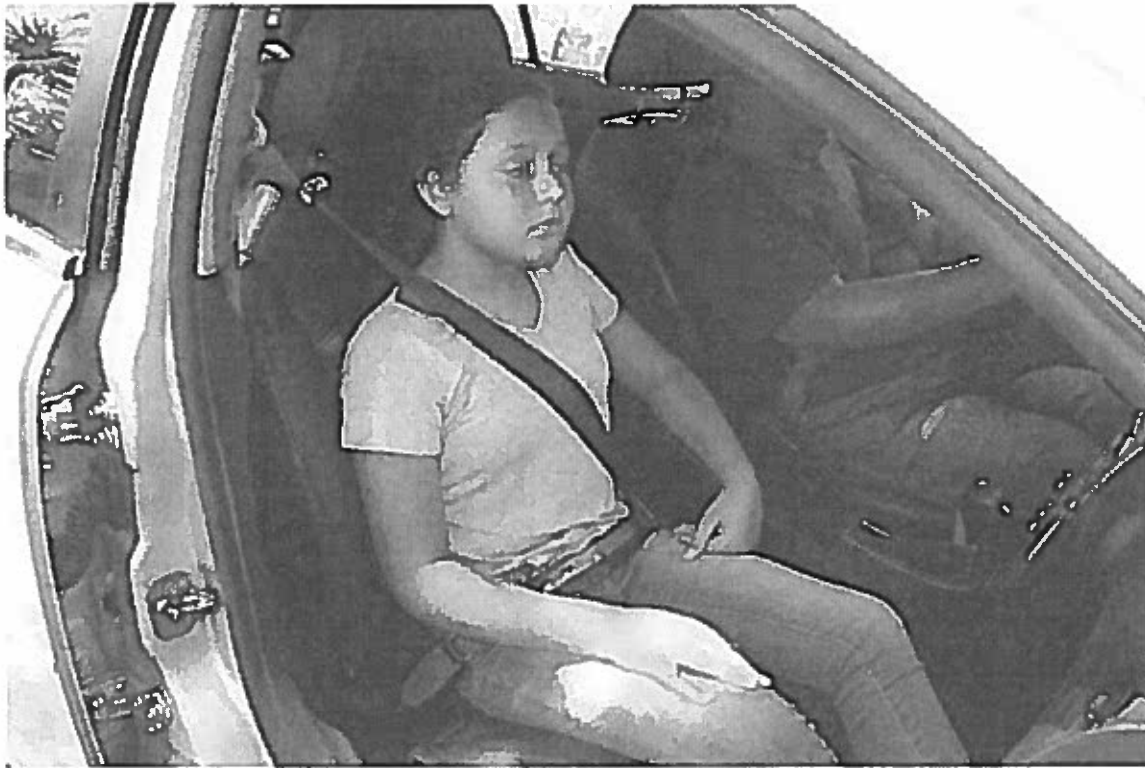
*Figure 6: Surrogate properly wearing right-front seat belt*

When wearing the seat belt properly, the seat belt offered good fit for an occupant the size of K█████ F█████ (see Figure 6). With the surrogate seated in the right-front seat, the D-ring was approximately 44 inches from the outboard anchor.

Note that during the surrogate study, the origin of the webbing measurements was 4 inches inboard of the outboard anchor. Therefore, the distance from the outboard anchor is 4 inches greater than the measurement indicated by the tape measure in the photographs in Figures 6 and 7.

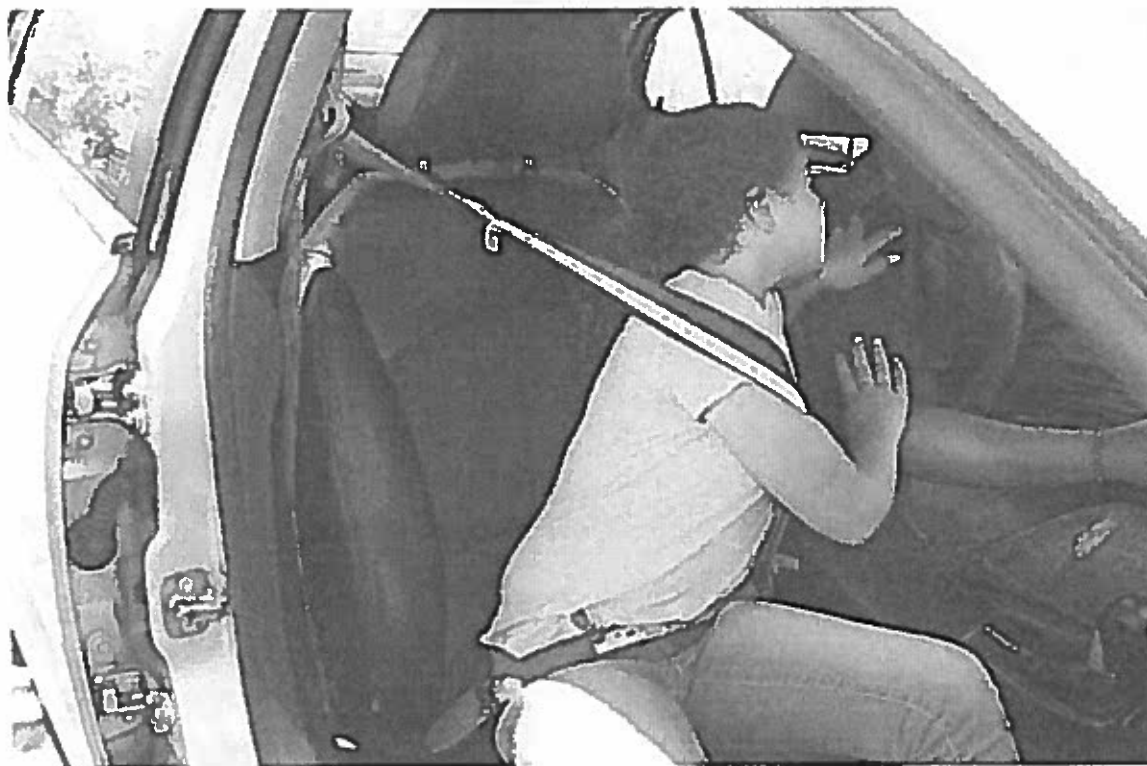
*Figure 7: Surrogate with D-ring at approximately 49 inches*

The surrogate was also placed in a pre-crash position that was consistent with the physical evidence on the subject seat belt and consistent with K[REDACTED] F[REDACTED] injuries (see Figure 7). This position is consistent with K[REDACTED] F[REDACTED] turning and reaching toward the driver position as one might do to alert the driver. When the surrogate did this, the belt moved off her shoulder and onto her upper arm, and the D-ring was approximately 49 inches from the outboard anchor. Based on the physical evidence on the seat belt as well as the expected function of the pretensioners, this location is consistent with the approximate location of the D-ring along the webbing at the time that the pretensioners deployed early in the crash pulse. Based on the physical evidence K[REDACTED] F[REDACTED] therefore had additional webbing in the seat belt system (as compared to a properly belted occupant), and Figure 7 illustrates one position consistent with this evidence.
